# BUILDING SURVEY REPORT

19th January 2023

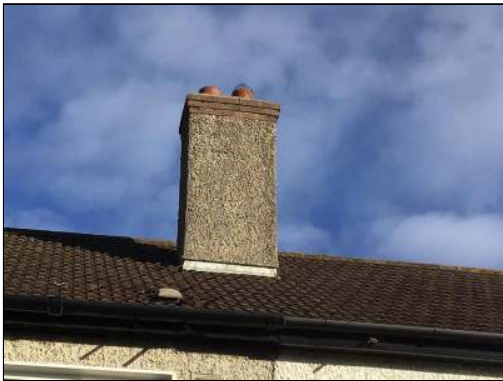
The chimney stack has a plaster finish. Crack in chimney to be investigated and repaired. From the ground inspection, the chimney appears to be an adequate height above the roof slope. i.e., 600mm -1.0m. We did not examine the flashing externally up close due to its height. Chimney Pot is damaged and needs to be replaced.

2

Photo - 1 Chimney to rear.

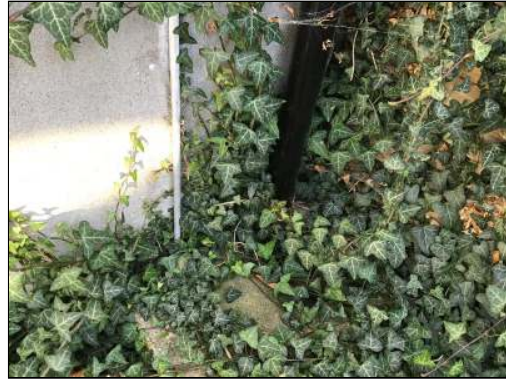
recommend replacing to a vented PVC finish which is of lower maintenance.  
Gully trap to rear is overgrown.

Photo - 5 Gully trap to rear is overgrown.

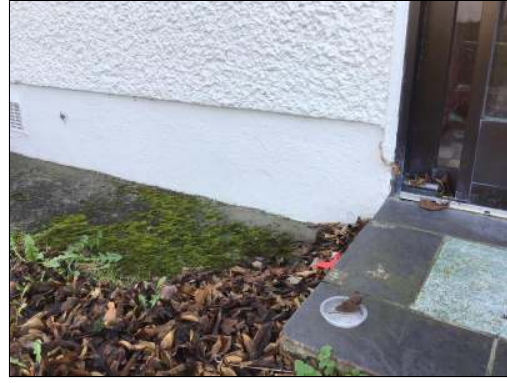
The outside walls are built of concrete blocks and brick.  
The outer face of the walls are coated/covered with plaster render.  
Due to the presence of a rendered plinth I was not able to confirm the presence of a DPC. However no dampness was detected internally and it is likely that an effective DPC exists. The external walls appear to be not dry lined throughout. No insulation.

Photo - 11 Plinth and front step

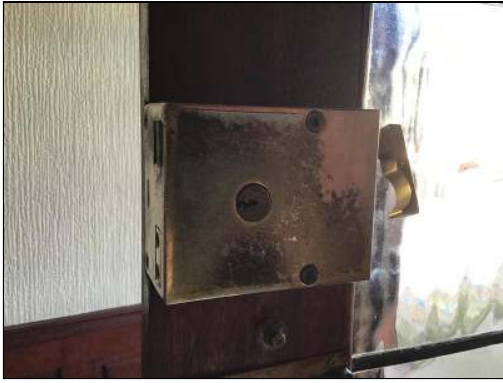
Photo - 16 Lock not secure

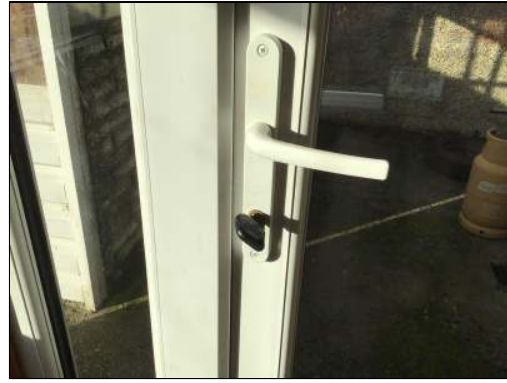
Photo - 17 Lock not secure

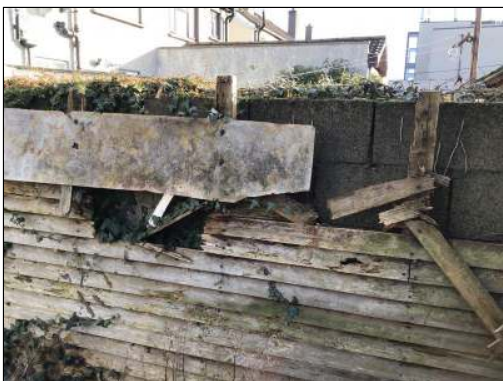
The external joinery includes fence and these are made of timber. The surfaces are varnished. Fence in very poor condition.

2

Photo - 19 Fence in very poor condition

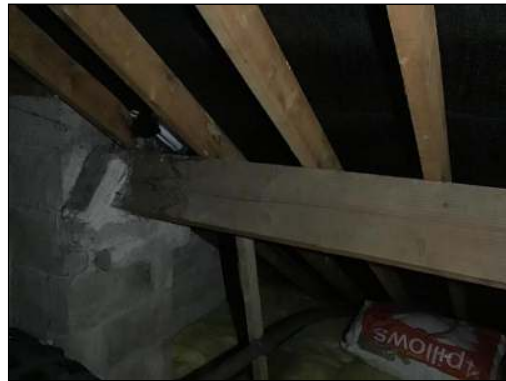
Photo - 26 Additional collar ties to be fitted

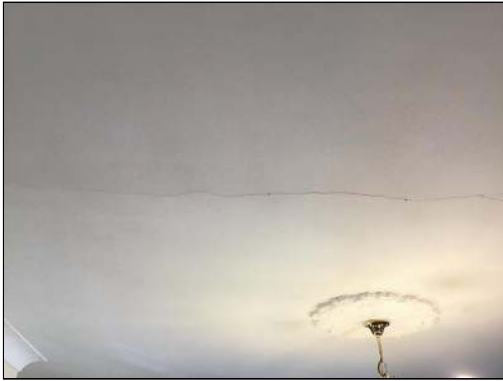
The ceilings are made of suspended timber with modern plasterboard finish. Stipple finish. Large shrinkage crack in Dining Room and bedroom ceiling to be investigated and repaired. Panelled ceiling in kitchen.

2

Photo - 29 Shrinkage cracks to be investigated and repaired.

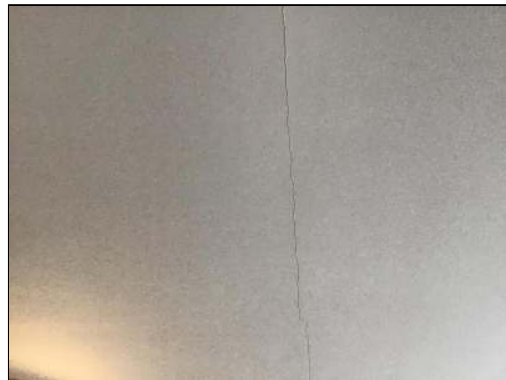
Photo - 32 Shrinkage cracks in ceilings to be monitored for possible future deterioration.

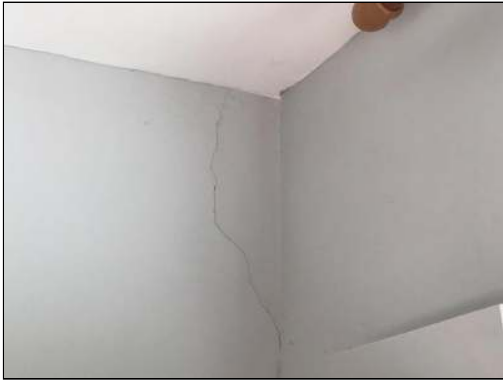
The internal walls and partitions are built of masonry and timber stud with skim plaster finish. Although I could see no particular problems now, a heavy lining paper covers the walls. Removing this during redecoration may damage the plaster and you should plan for additional repairs. Shrinkage crack in rear bedroom to be investigated and repaired.

Photo - 35 Shrinkage crack in rear bedroom to be investigated and repaired.

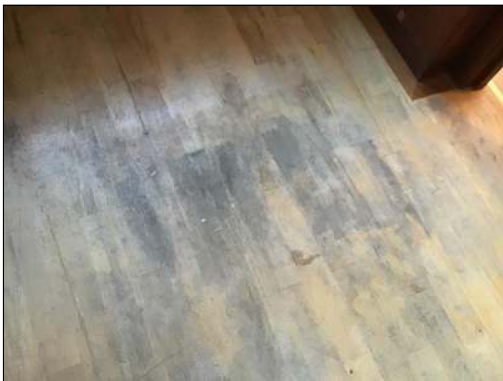
Photo - 36 Laminate finish. Badly stained in some areas.

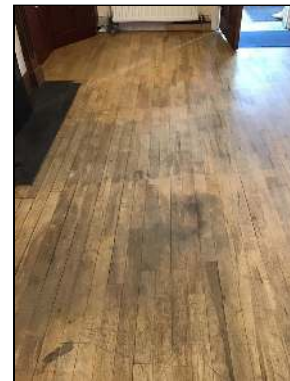
Photo - 37 Laminate finish. Badly stained in some areas.

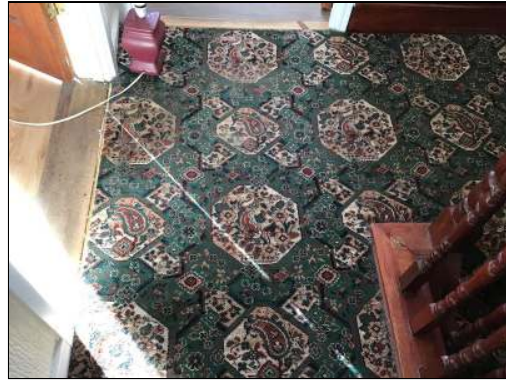
Photo - 39 Carpet on stairs and landing. Very creaky floor on landing.

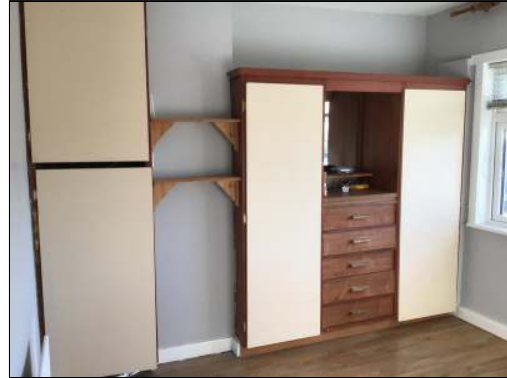
Photo - 43 The Bedroom fittings are basic DIY.

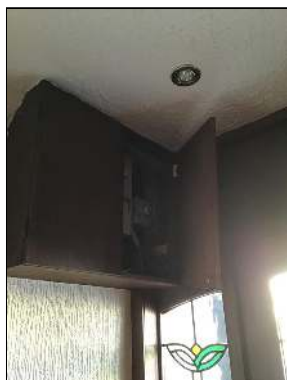
Photo - 46 Fuse board door is loose.

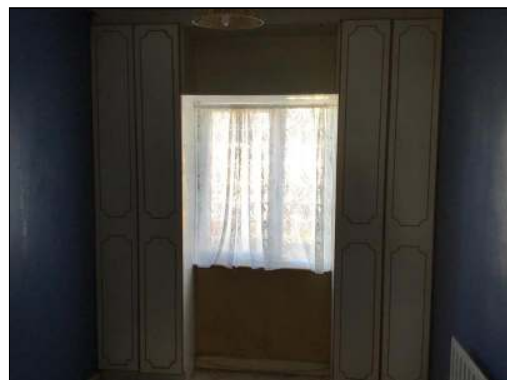
Photo - 47 The Bedroom fittings are basic DIY.

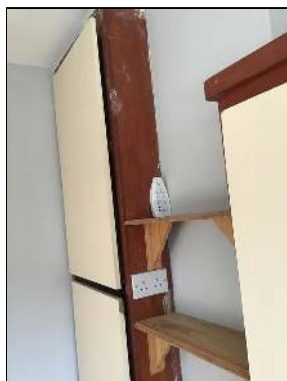
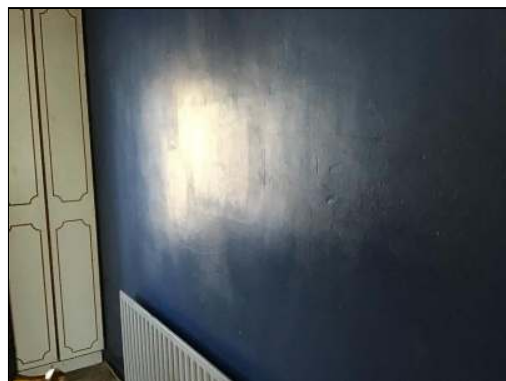
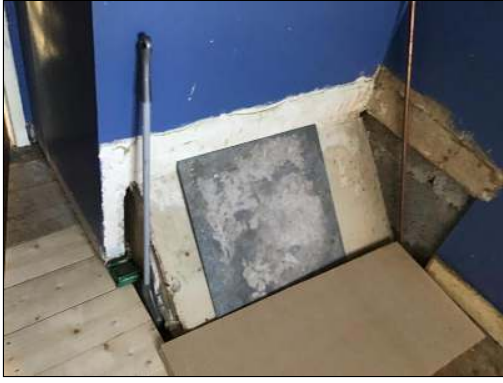
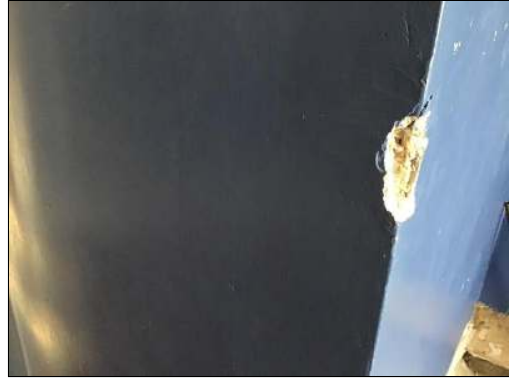
The internal decorations are generally in good condition but some areas are marked and in need of redecoration.

2

Photo - 56 Poor internal decor

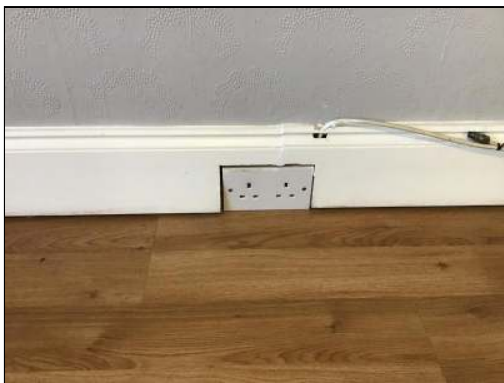
3

Photo - 60 Sockets too close to the floor

There appears to be a lot of "upgraded" wiring fitted throughout the property. The workmanship is shoddy and untidy and I suggest that the entire house is professionally rewired and a new RCB type fuse board fitted in place of the dated screw in type presently in place.

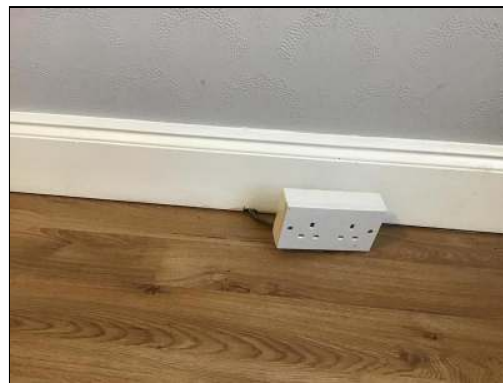
Photo - 61 Sockets too close to the floor, and loose wiring.

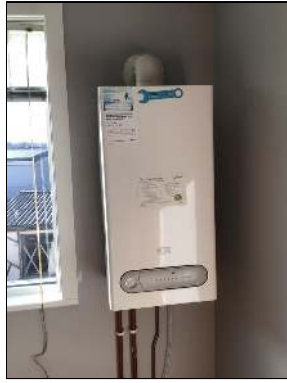
Photo - 64 Boiler to be serviced.

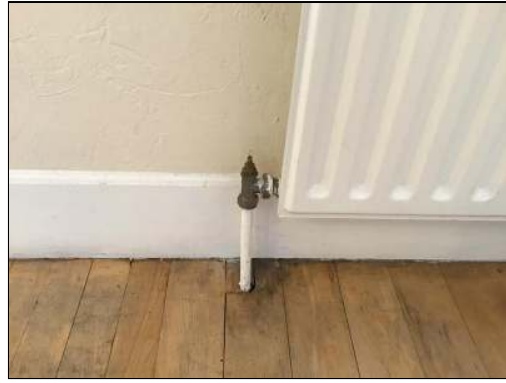
Photo - 65 Radiator caps missing.

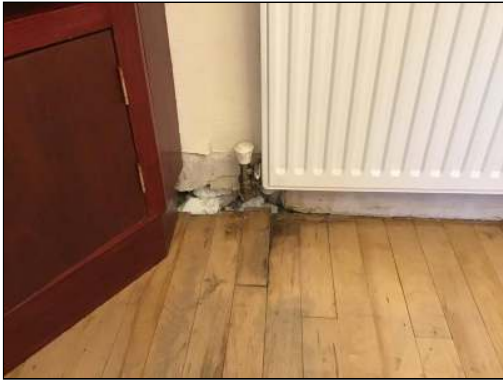
The property is heated by mains gas.  
The property is heated by a boiler.  
Boiler to be serviced.  
Radiator valve covers missing.  
Damaged walls at pipework to be repaired.

Photo - 66 Poor workmanship at heating pipes.

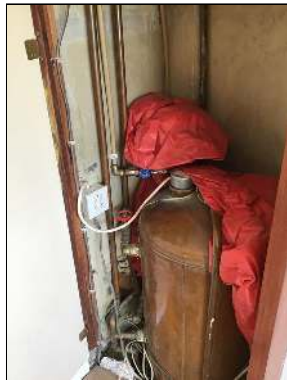
The hot water is provided by the heating system boiler. Backup immersion in the hotpress.  
Cylinder not adequately insulated.  
No labels on valves and stopcocks in the hotpress  
Check all plumbing prior to purchase.  
Wall damaged inside hotpress.

Photo - 67 Cylinder not adequately insulated.

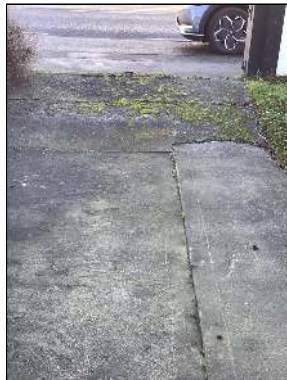
The property has private gardens to the front and rear.  
The private gardens are in need of attention. Driveway is cracked.

3

Photo - 73 The private gardens are in need of attention. Driveway is cracked.

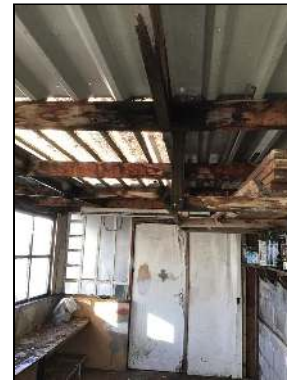
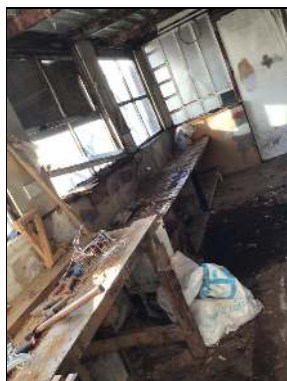
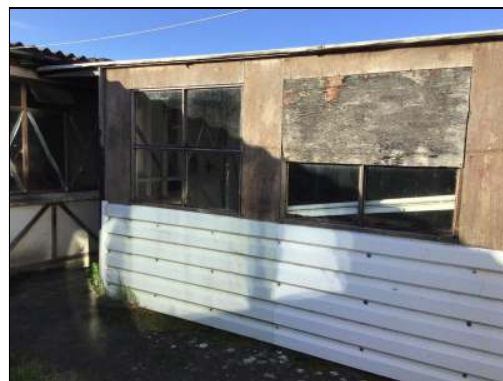
The outbuildings on the property consist of timber sheds in the rear garden.  
One is a workshop and one is a shed.  
Asbestos roof sheeting on Shed. Shed is weatherproof but not fit for human habitation.  
Workshop structure in poor condition. Roof is sagging and leaking.

Photo - 74 Workshop structure in poor condition. Roof is sagging and leaking.

You should ask your legal adviser to confirm whether the extension and sheds have the necessary Certificate of Exemption from Planning approval and compliance with Building Regulations.  
Outhouses are in poor condition and it may be easier to just remove them completely and rebuild as required keeping to the Exemption limits currently exceeded.

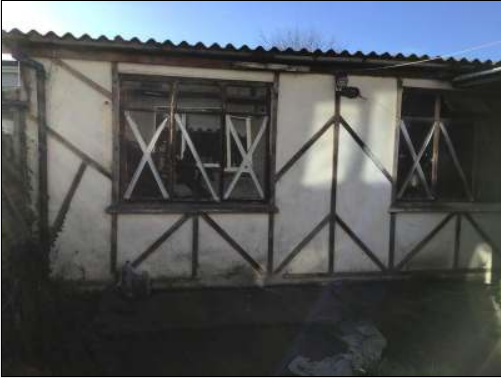
*Photo - 77 Shed is weatherproof but not fit for human habitation.*

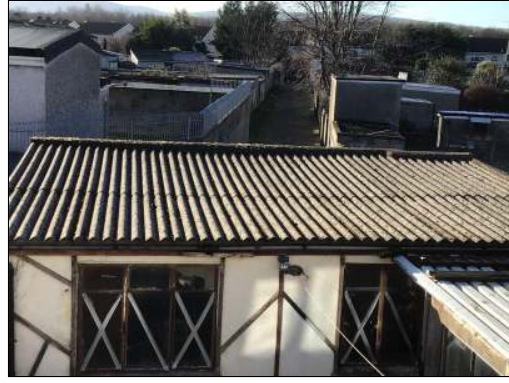
*Photo - 78 Asbestos sheeting on shed roof*

Because of the Asbestos content noted earlier in the report, these areas should not be disturbed without prior advice from a licensed asbestos specialist or a contractor experienced in this type of work.

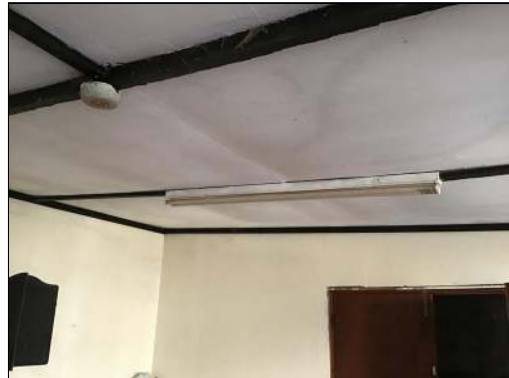
*Photo - 82 Shed roof is sagging*

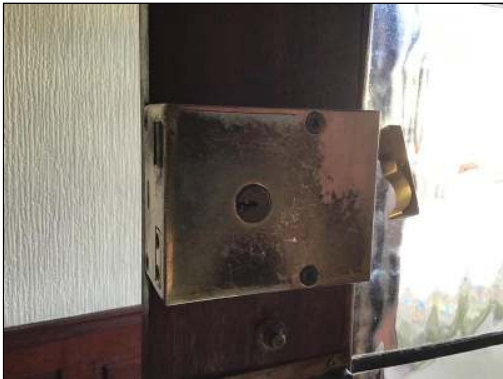
The property is not protected by an alarm. The locking arrangement on the front and rear doors are not up to current standards and are a security risk. These should be improved soon.

Photo - 85 Lock not secure

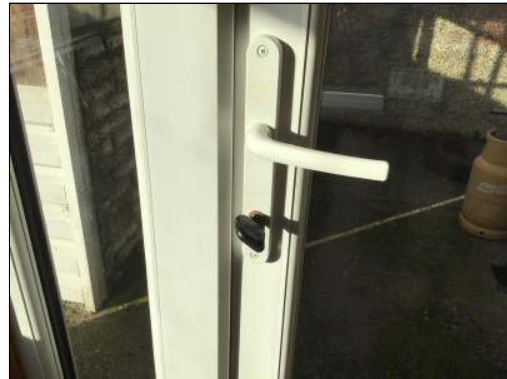
Photo - 86 Lock not secure
