# BUILDING SURVEY REPORT

19th January 2023

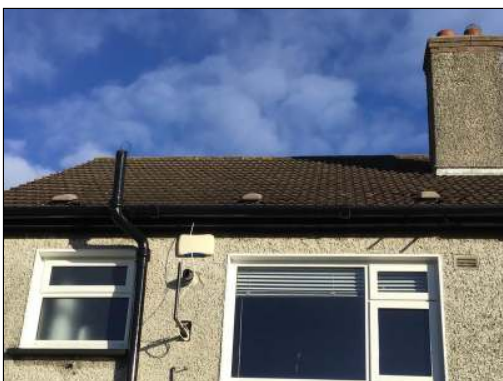
The main roof on the property is pitched. The main roof is covered with concrete tiles. There was no visible evidence of deflection from an external point of view at the time of inspection. The extension roof is covered with built up felt. Flat roof. To be monitored for possible future deterioration. No ponding and no visible evidence of leaks at time of inspection.

Photo - 2 Main roof

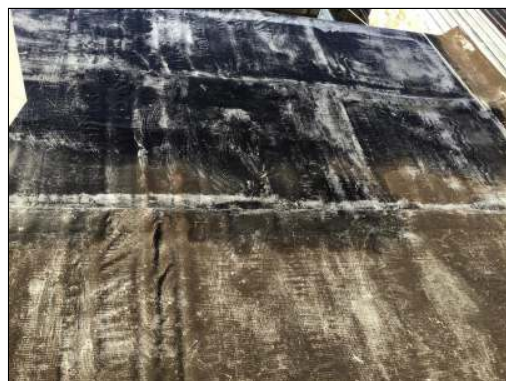
Photo - 3 Flat roof over extension

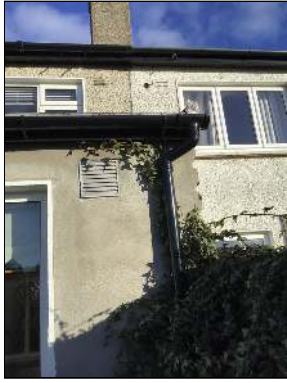
Photo - 4 Rain water pipes and gutters

recommend replacing to a vented PVC finish which is of lower maintenance.  
Gully trap to rear is overgrown.

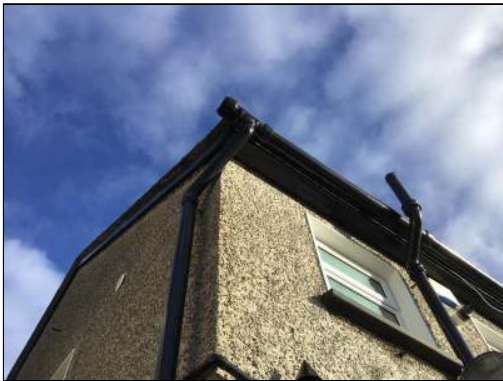
Photo - 6 Rain water pipes and gutters

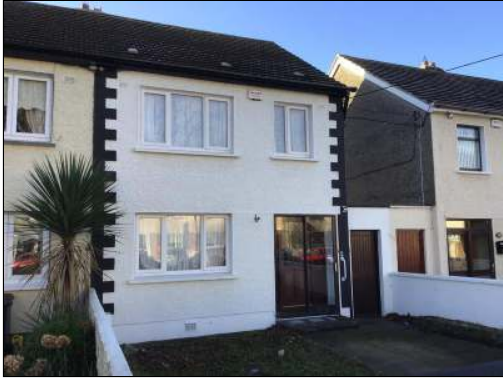
The outside walls are built of concrete blocks and brick.  
The outer face of the walls are coated/covered with plaster render.  
Due to the presence of a rendered plinth I was not able to confirm the presence of a DPC. However no dampness was detected internally and it is likely that an effective DPC exists. The external walls appear to be not dry lined throughout. No insulation.

Photo - 10 Front elevation

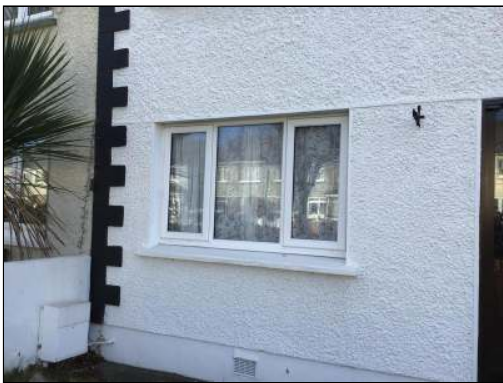
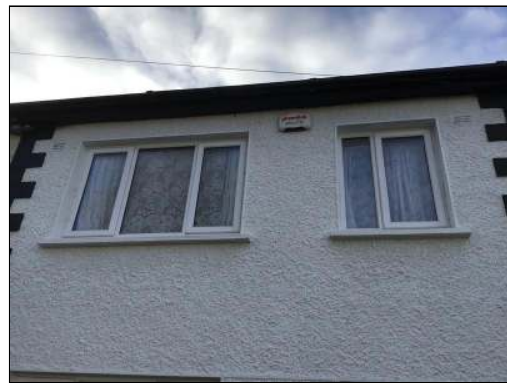
The double glazed windows are made of uPVC. Relatively new. All appear to be in good condition.

Photo - 12 Typical window

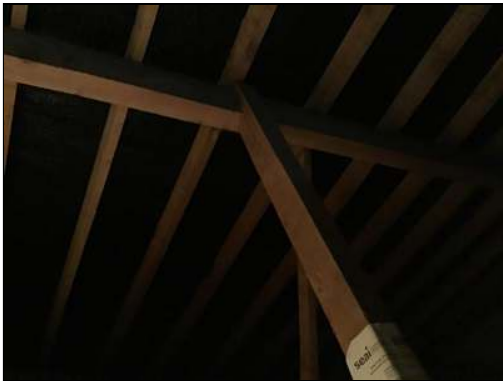
The internal roof structure consists of a cut timber system. Attic timbers appear to be in good condition. The level of thermal insulation is less than current standards. This will result in lower internal temperatures and higher heating costs. Additional collar ties to be fitted. May be possible to convert Attic to an additional Storage Room.

Photo - 23 Roof timbers in good condition

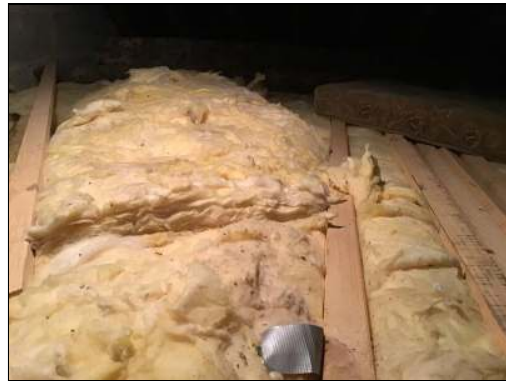
Photo - 24 Rockwool insulation

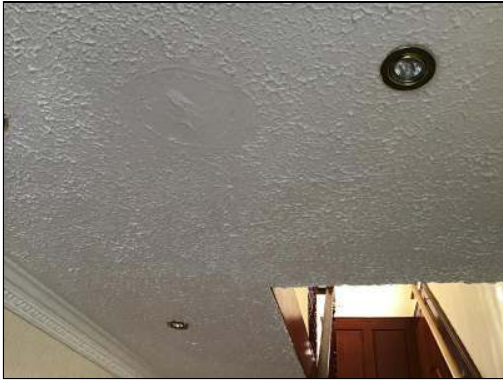
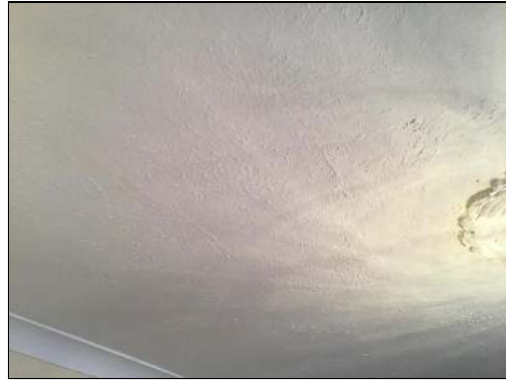
The ceilings are made of suspended timber with modern plasterboard finish. Stipple finish. Large shrinkage crack in Dining Room and bedroom ceiling to be investigated and repaired. Panelled ceiling in kitchen.

Photo - 27 Stipple ceiling

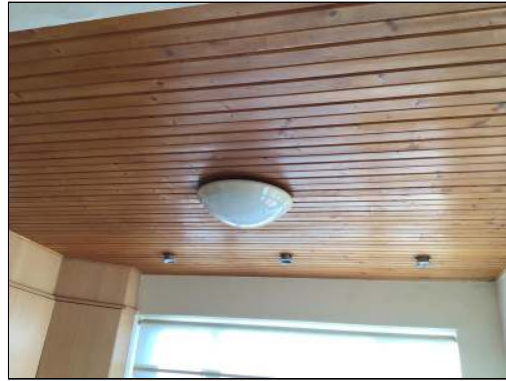
Photo - 30 Panelling on ceiling in kitchen

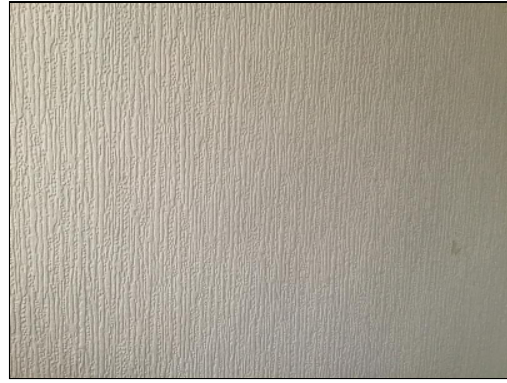
The internal walls and partitions are built of masonry and timber stud with skim plaster finish. Although I could see no particular problems now, a heavy lining paper covers the walls. Removing this during redecoration may damage the plaster and you should plan for additional repairs. Shrinkage crack in rear bedroom to be investigated and repaired.

Photo - 34 Heavy lining paper

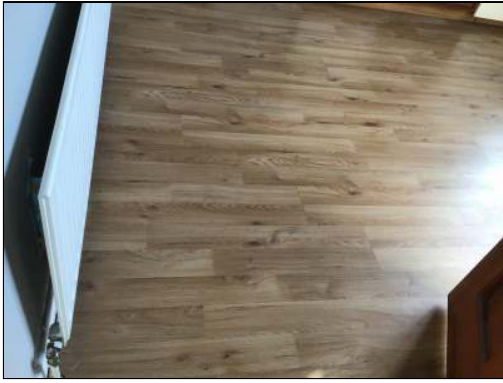
Photo - 38 Laminate in bedrooms

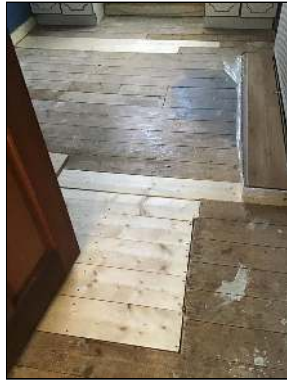
Photo - 40 T&G flooring in bedrooms

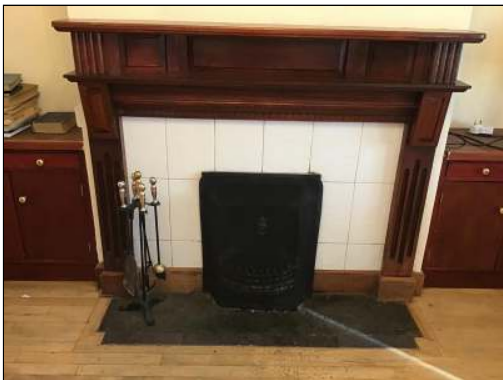
Photo - 41 Fireplace in living room

You should ask your legal adviser to check whether: the solid fuel burning appliance has been safety checked and whether the chimney has been swept within the last 12 months. If this has not been done, you should ask an appropriately qualified person to do this before you use the appliance.

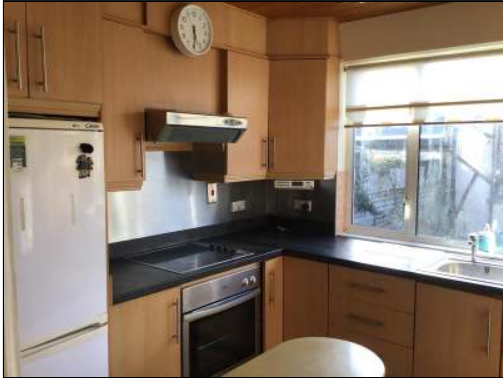
The Kitchen has modern fitted units with Formica worktops.  
 Built-in fittings can conceal a variety of problems that are only revealed when they are removed for repair. For example, kitchen units often hide water and gas pipes, or obscure dampness to walls.  
 The Bedroom fittings are basic DIY.  
 Built in units in front hall also.  
 Fuse board door is loose.

Photo - 42 Kitchen units

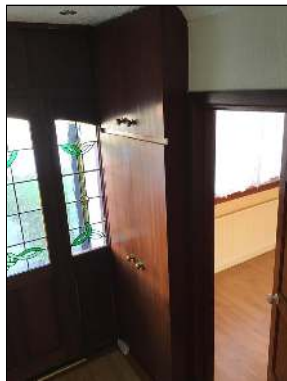
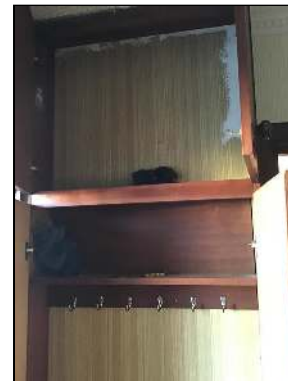
Photo - 44 Built in units in front hall.

Photo - 45 Built in unit in hall.

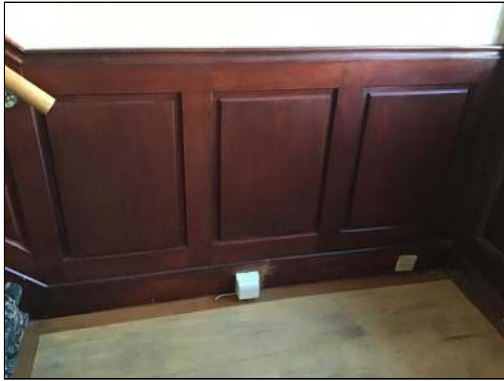
Photo - 50 Wainscoting in hall and along stairs

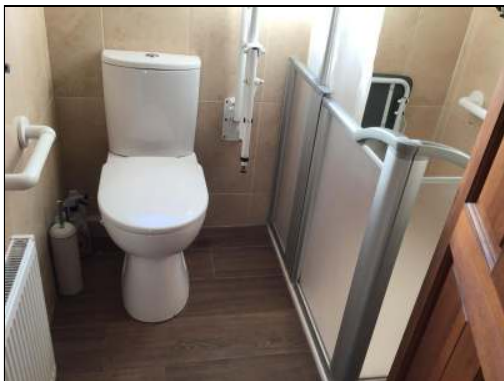
The fittings and appliances in the Bathroom comprise of WC, WHB and electric shower. No visible evidence of leaks from fittings or fixtures at time of inspection.

Photo - 52 Assisted living Bathroom fittings and fixtures

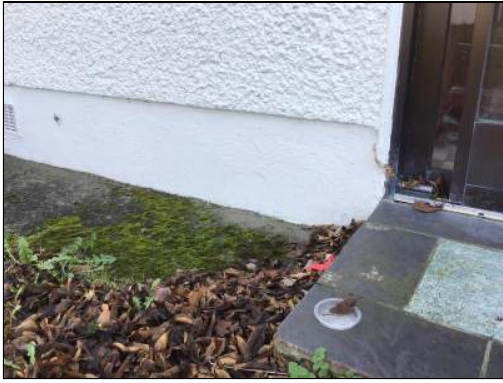
Due to the presence of a rendered plinth I was not able to confirm the presence of a DPC (damp-proof course). However no dampness was detected internally and it is likely that an effective DPC exists.

Photo - 54 Plinth and front step

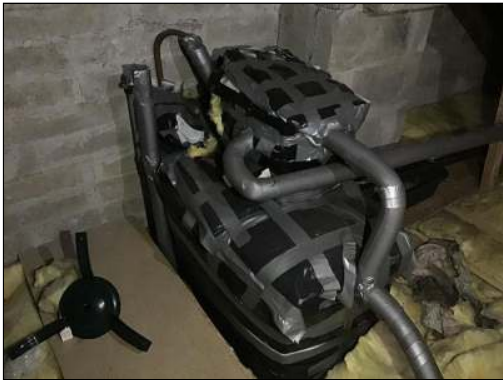
Attic fully insulated.

Photo - 55 Fully insulated tank and pipes in attic

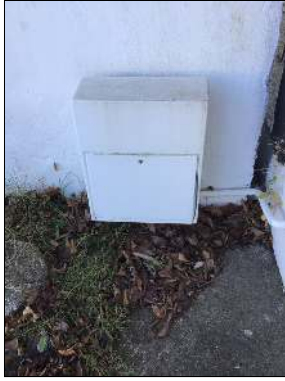
Photo - 62 Gas meter box in front garden

A registered Gas Installer (RGI) should check all heating systems and appliances, for example, boilers, individual room heaters, all open fires, etc on an annual basis. Heating systems and appliances that have not been checked may be a safety hazard.

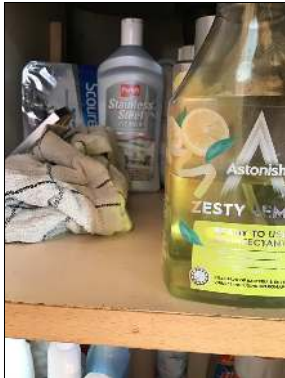
Photo - 63 The stop valve within the property is located behind a panel under the Kitchen sink.

All plumbing to be checked by a qualified Plumber PRIOR to purchase.

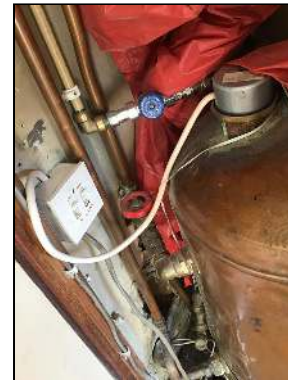
Photo - 68 No labels on valves and stopcocks in the hotpress

The hot water is provided by the heating system boiler. Backup immersion in the hotpress.  
Cylinder not adequately insulated.  
No labels on valves and stopcocks in the hotpress  
Check all plumbing prior to purchase.  
Wall damaged inside hotpress.

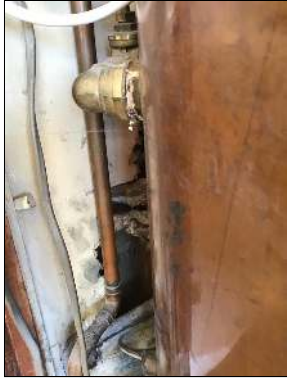
Photo - 69 No labels on valves and stopcocks in the hotpress

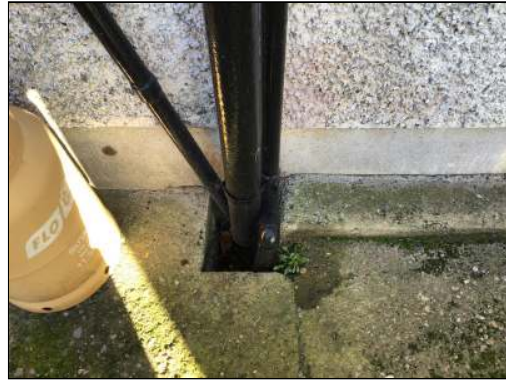
Photo - 71 Gully trap

The property is connected to the public sewer and the drainage system consists manholes, Aj's and gully traps in the front and rear gardens. Gully traps to be cleaned out.

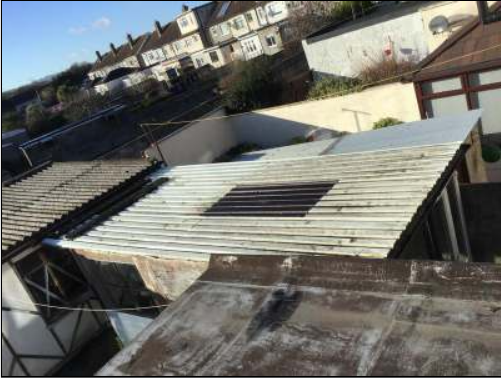
The outbuildings on the property consist of timber sheds in the rear garden.  
One is a workshop and one is a shed.  
Asbestos roof sheeting on Shed. Shed is weatherproof but not fit for human habitation.  
Workshop structure in poor condition. Roof is sagging and leaking.

*Photo - 79 Metal sheeting on workshop roof*

You should ask your legal adviser to confirm whether the extension and sheds have the necessary Certificate of Exemption from Planning approval and compliance with Building Regulations.  
Outhouses are in poor condition and it may be easier to just remove them completely and rebuild as required keeping to the Exemption limits currently exceeded.

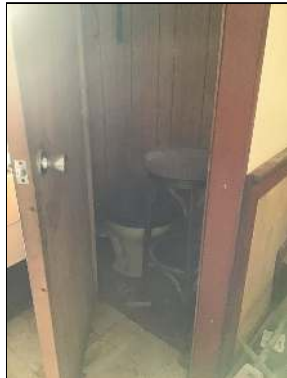
*Photo - 81 Sub standard WC fitted in Shed, not connected*

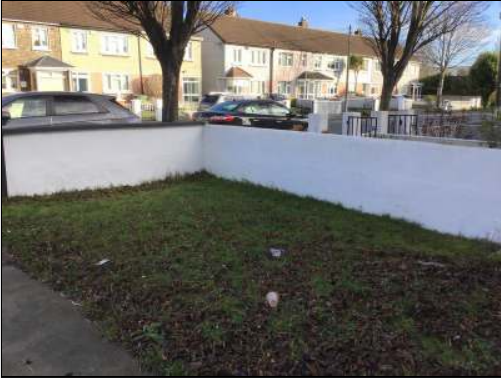
*Photo - 84 Front boundary wall*

The boundaries of the property consist of block walls.
